## **Arboricultural Impact Assessment**

### **Oxford Falls Grammar School – Library & Admin Building**

Version 2

December 2019

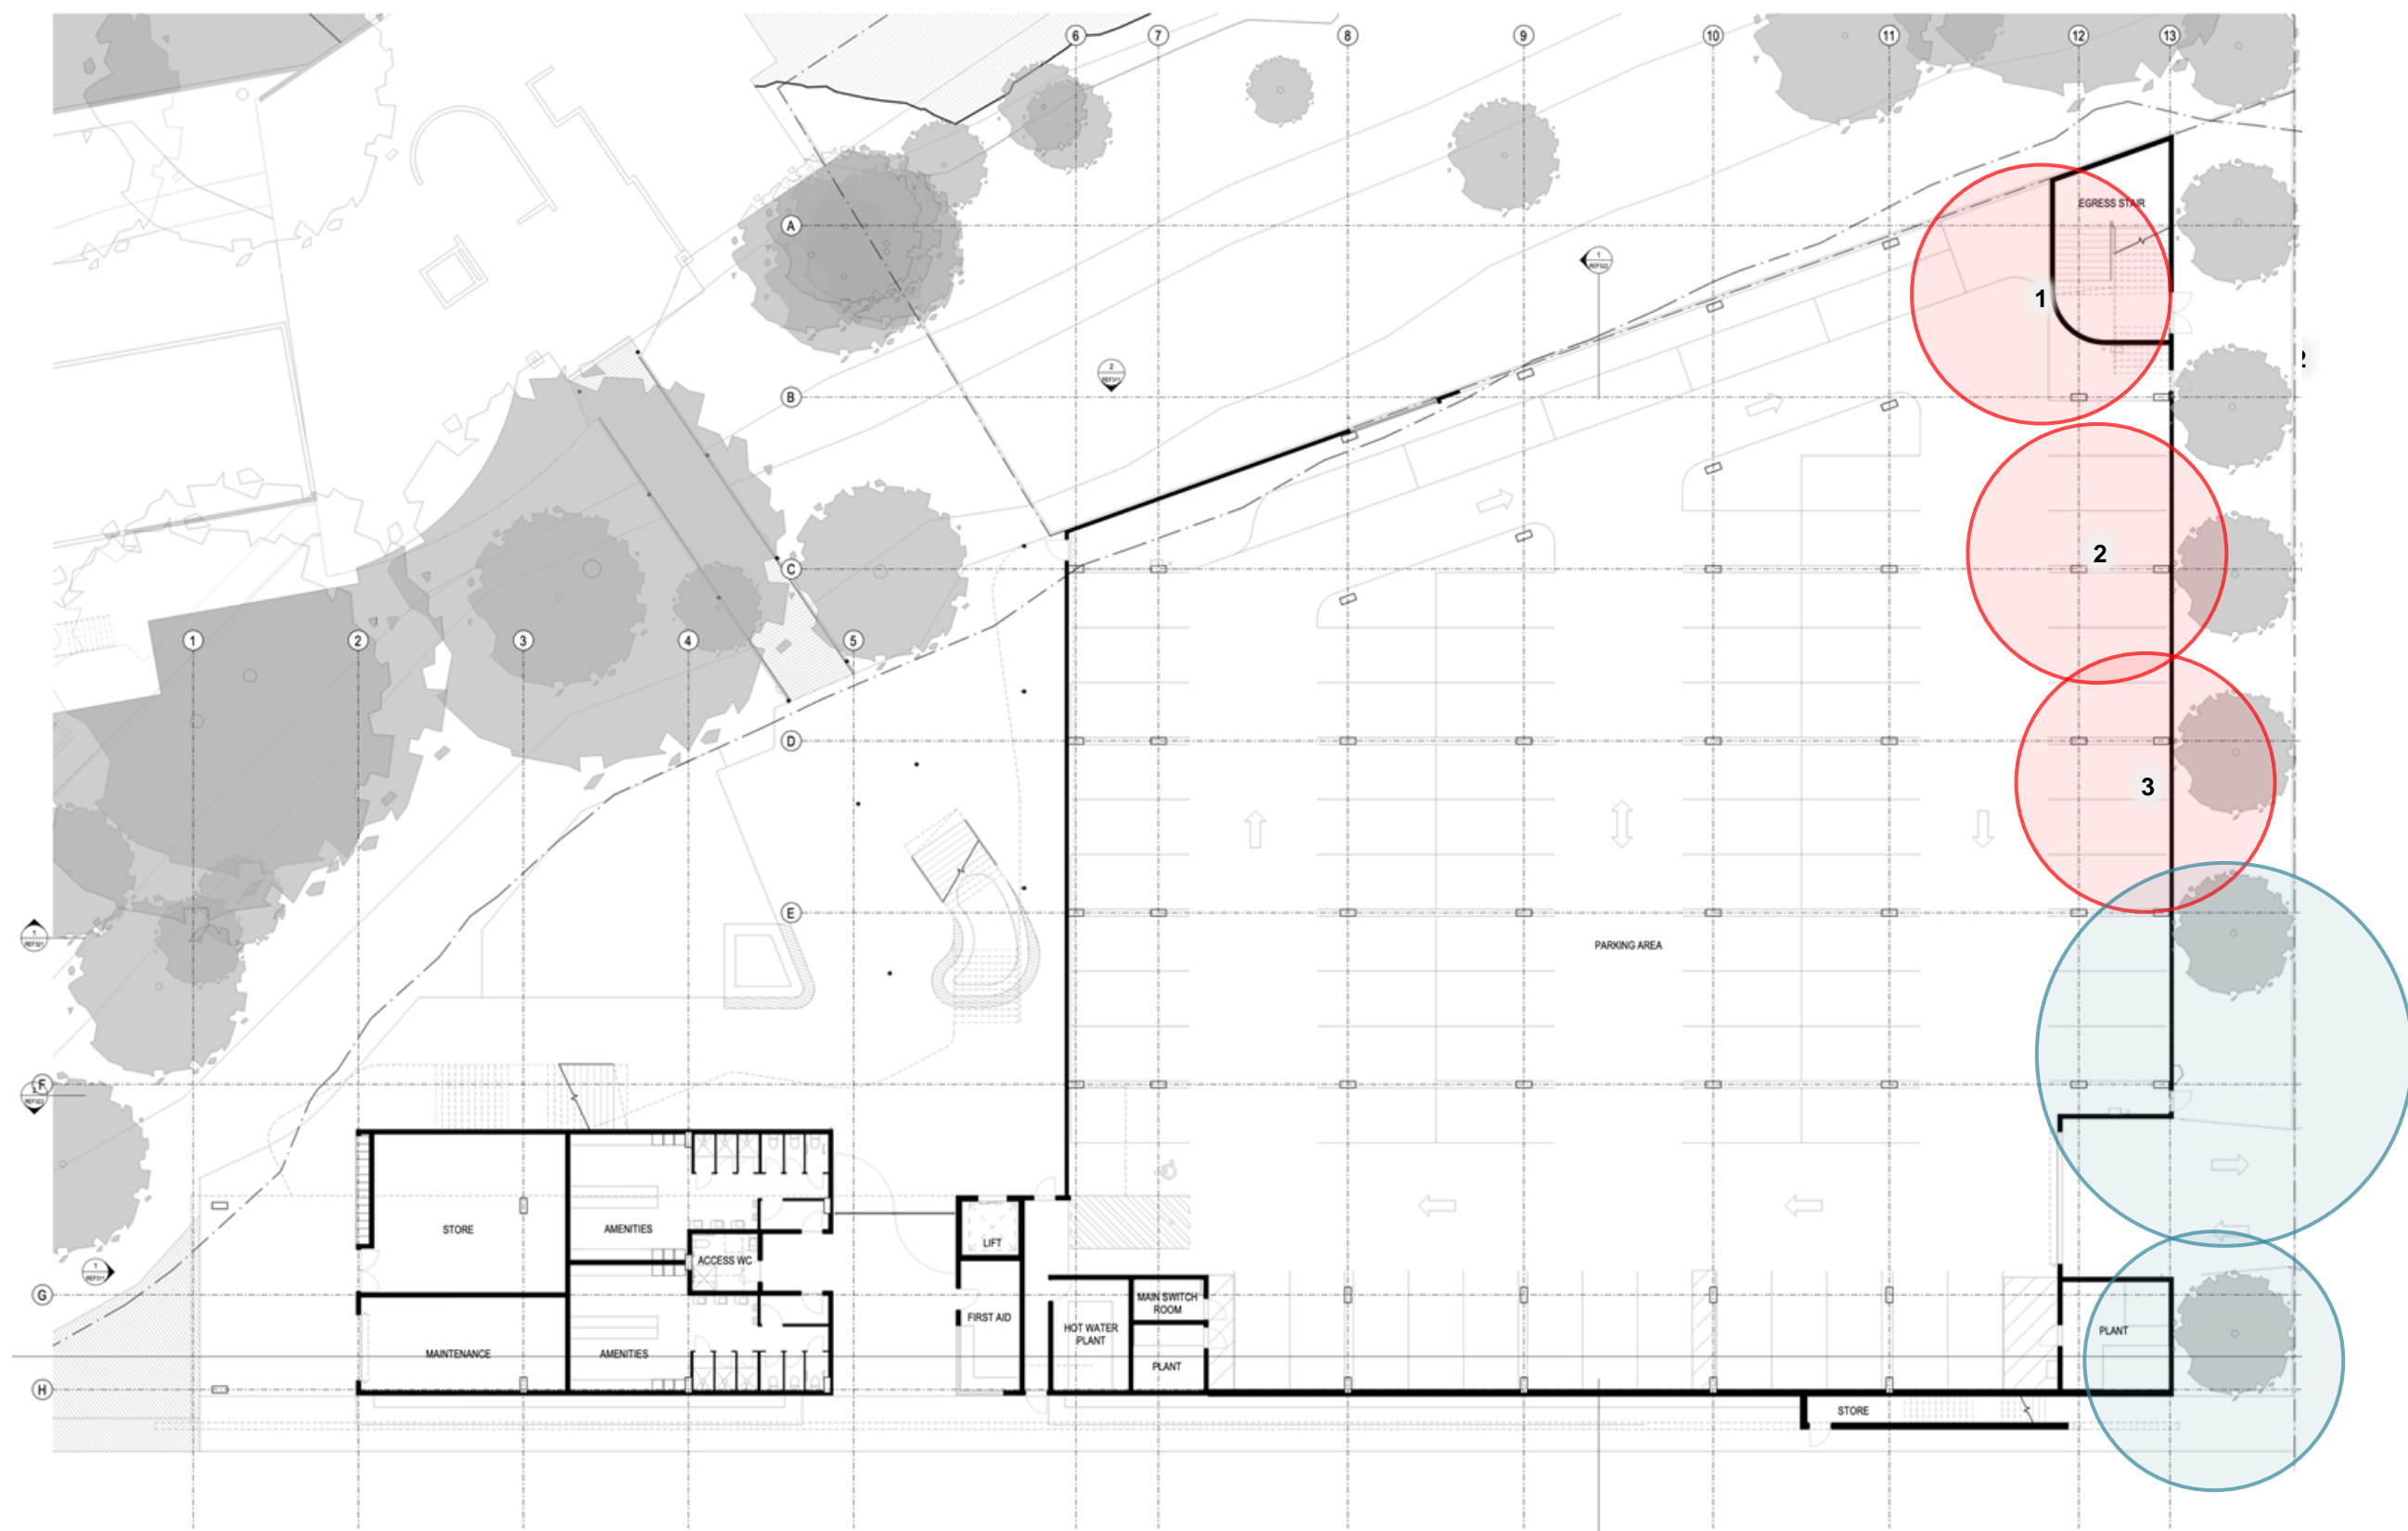
## Appendix I - Impact Assessment

The subject tree is located wholly within the construction footprint of the proposed development footprint.

**Two** trees (**id. 1 & 2**) with a **HIGH** retention value and **One** tree (**id. 3**) with a **Medium** retention value are located wholly within the development footprint.

**Total encroachment (100%): Subject trees 1, 2 & 3** are located wholly within the development footprint. Under the current proposal, these trees cannot be successfully retained and are recommended for removal as part of this development.
